# THE TSUNAMI

## Alaskan Earthquake, 1964 :

### Engineering Evaluation

TECHNICAL MEMORANDUM NO. 25

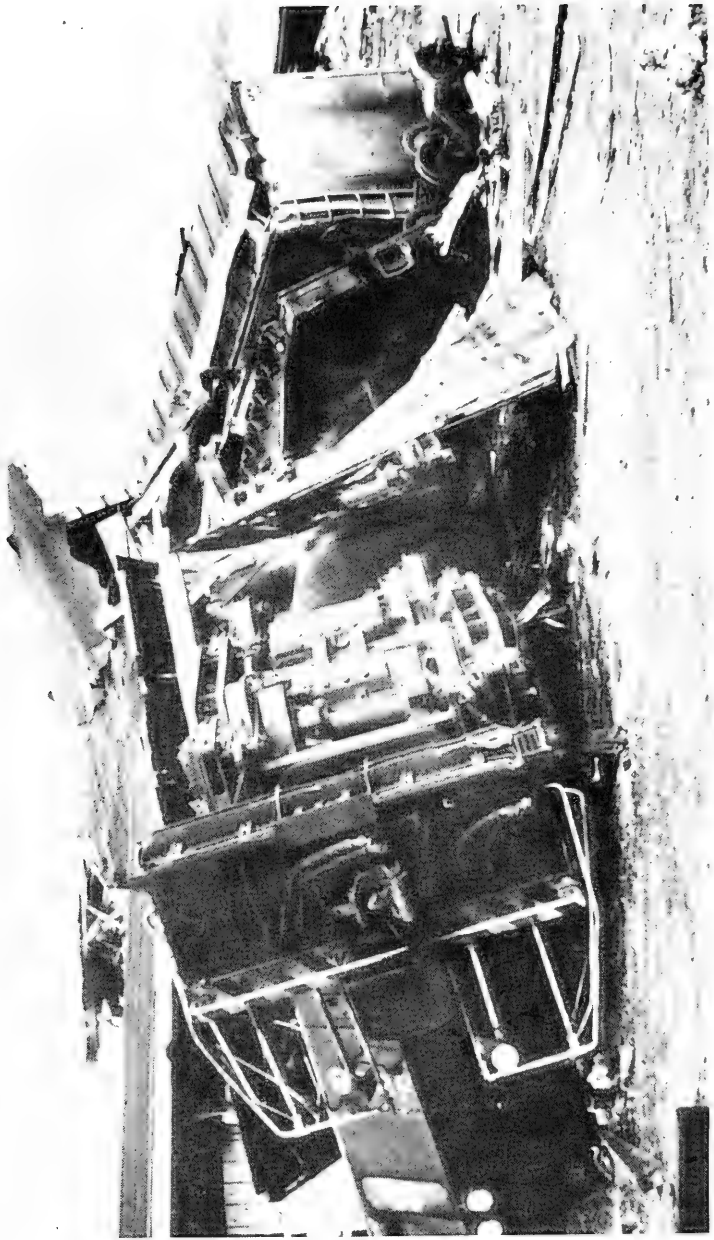
Figure 151 125-ton Locomotive transported and overturned by waves near the engine house. (Photograph by Irvin Cook, Anchorage)

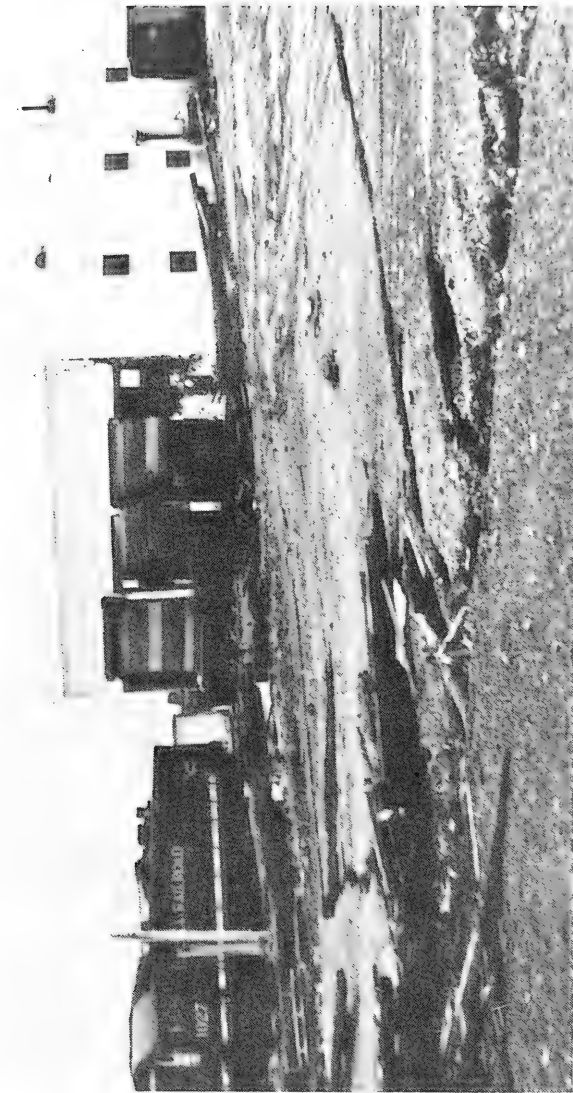
Figure 153 Engine "Roundhouse" near the Alaska Railroad marshalling yards, showing relatively light damage from the Earthquake and waves. (Photograph by Alaska Railroad)

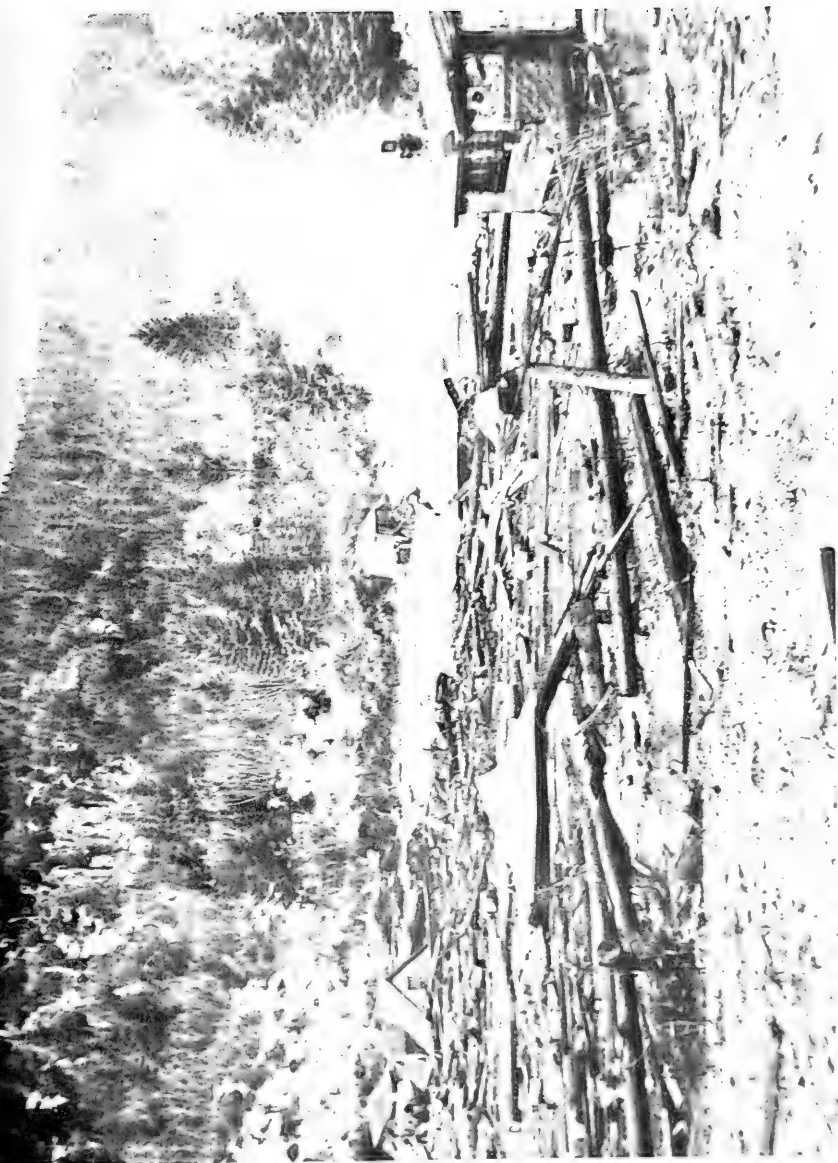
Figure 154 Wreckage of houses and boats carried into the lagoon by the Seismic Sea Waves. Rooftop in center field was the former Seward Radio Station. House at right came from a site near Fourth Street and Van Buren Avenue (see Figure 136).  
(Photograph by Dave Thompson, Seward)

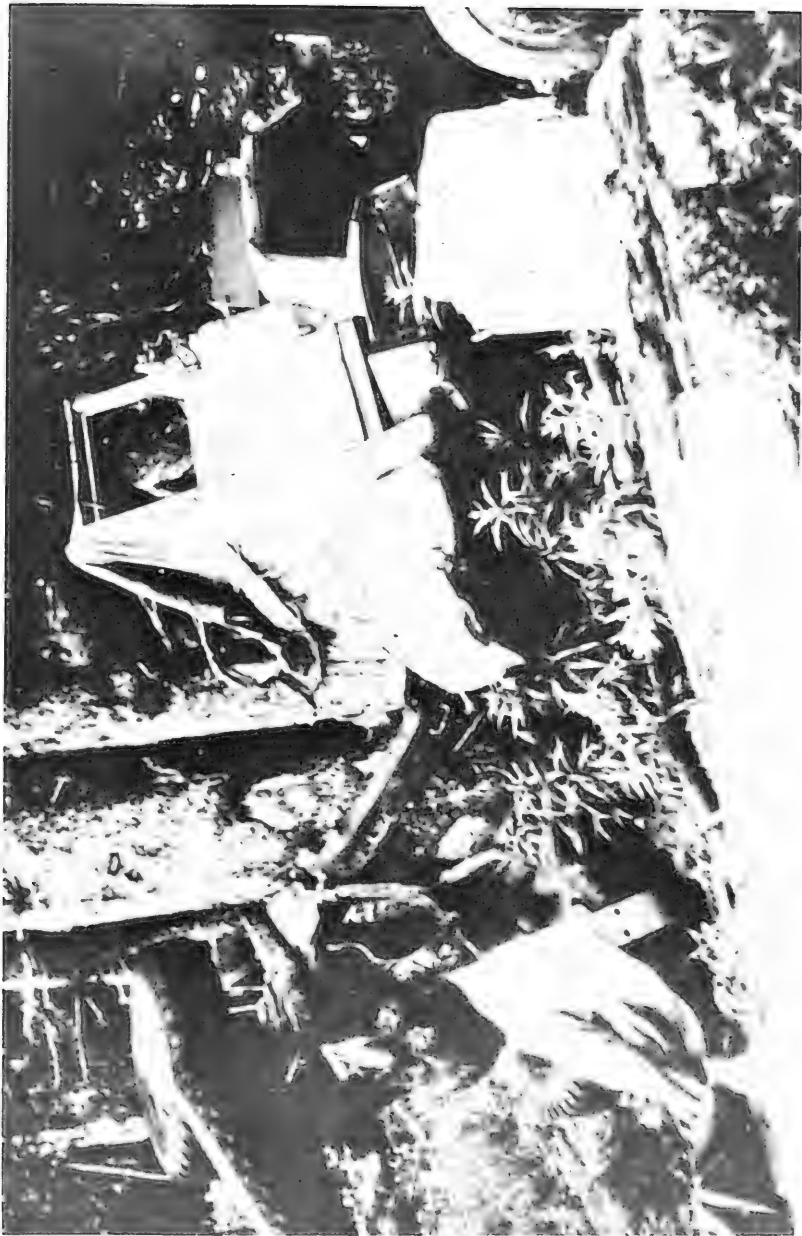
Figure 156 Remains of 6-ton truck at Lowell Point near Seward, 32 feet above water level, left by the Seismic Sea Waves of March 27, 1964. (Photograph by Pierre St. Amand)

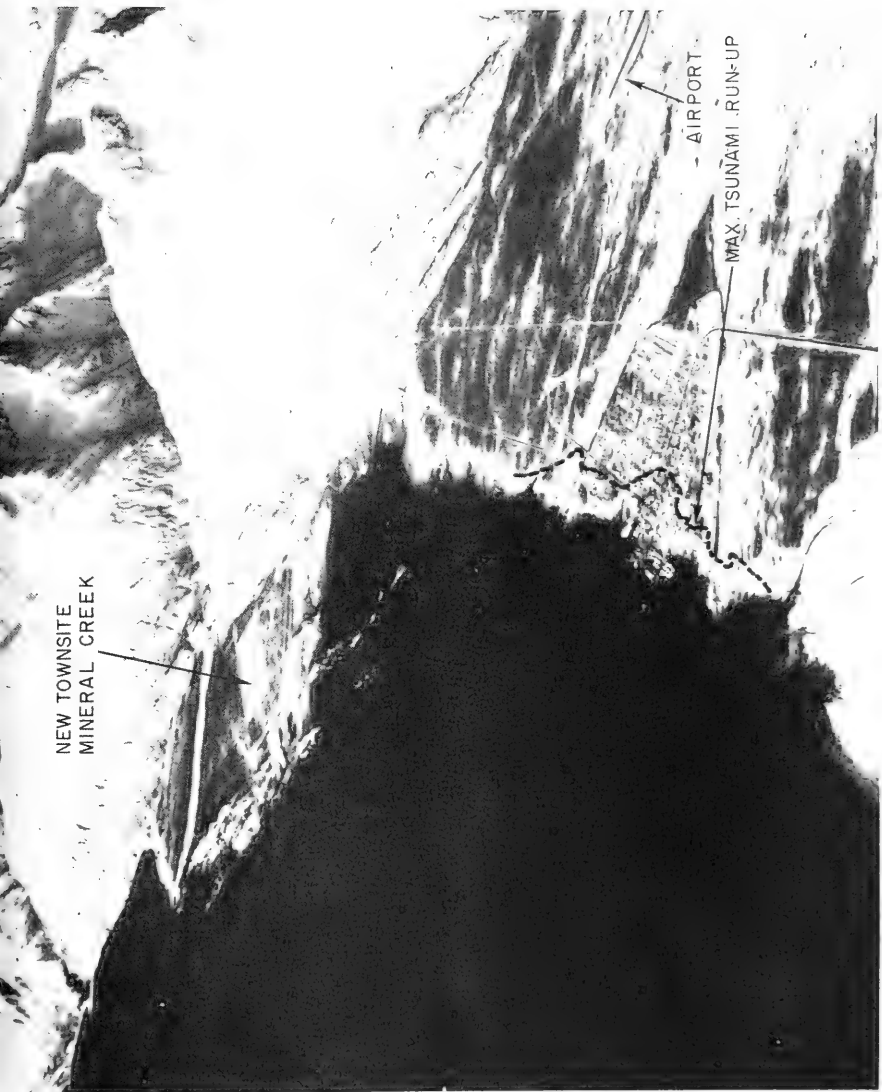
Figure 164 Valdez after the Earthquake. (Photograph by U. S. Army)

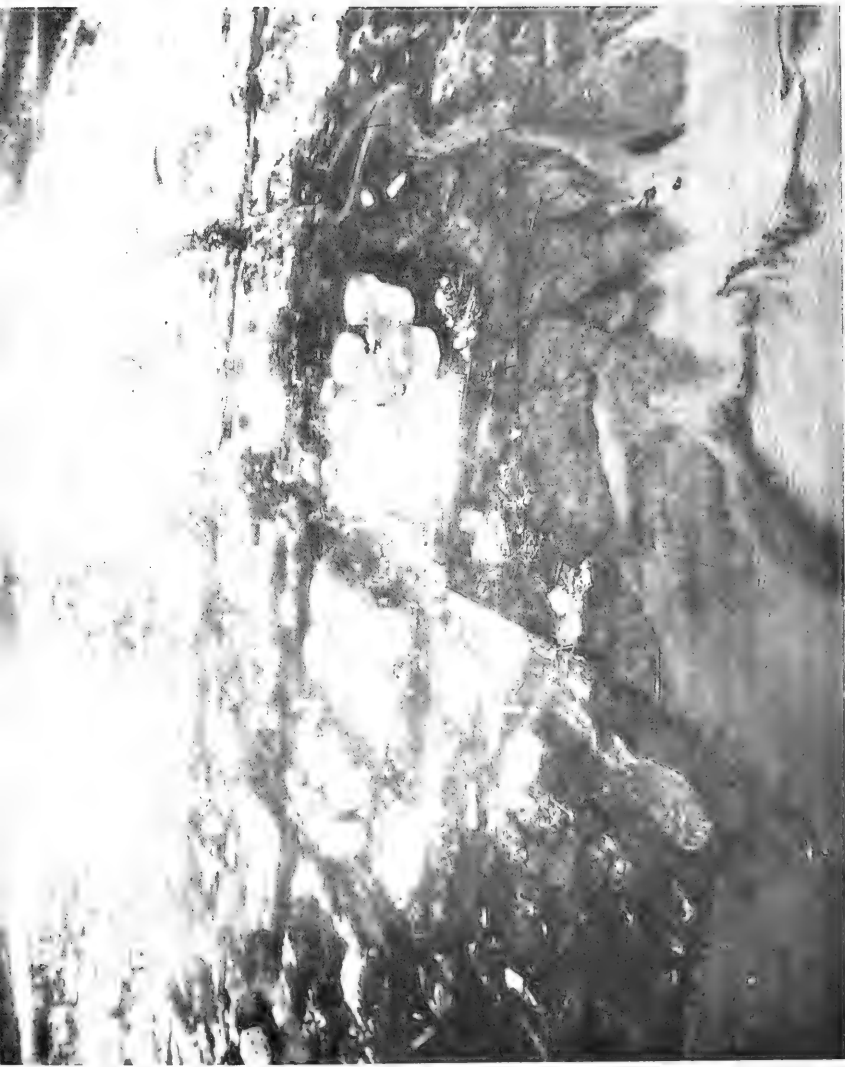
Figure 174 Aerial view of the devastation of the waterfront at Valdez in the vicinity of the Standard Oil Company Tank Farm. Note the relatively undamaged building in left center field. It can be identified in Figure 172. Remains of the south pier are at lower left. (Photograph by U. S. Army)

Moments later Nelson, looking back toward Valdez, photographed this fantastic withdrawal of water and recorded the scene reproduced from his film as a panoramic composite view shown in Figure 172. The direction and location of the picture are inferred in Figure 166. Mud flats were forming behind the ship as it hurtled south. The awesome nature of the mass formed by the submarine slide (see Figure 167f) is shown in Figure 173 which is another panoramic view from Nelson's film, photographed from the approximate position (f) in Figure 166, using the zoom lens for greater detail. It is believed that the location of the scarp formed by the slump is revealed in the lower right-hand portion of the aerial photograph, Figure 174, taken within a few days of the earthquake.

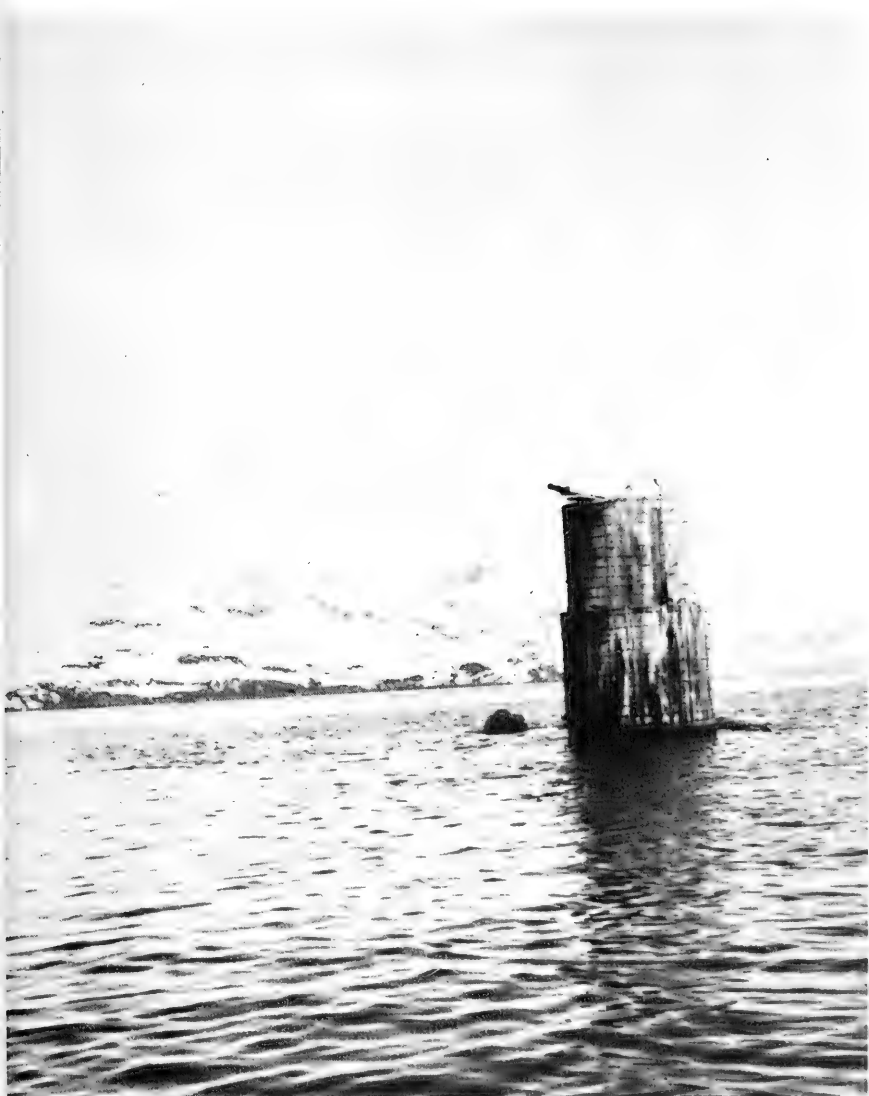
Figure 178 Concrete pylon of the navigation light located at the entrance to Port Valdez (see Figure 177). The light was destroyed by a huge wave that passed southwards out of Valdez Narrows. Steel reinforcing rods at an elevation of about 37 feet above MLLW were bent in the direction of flow. (Photograph by H. Coulter & R. Migliaccio)

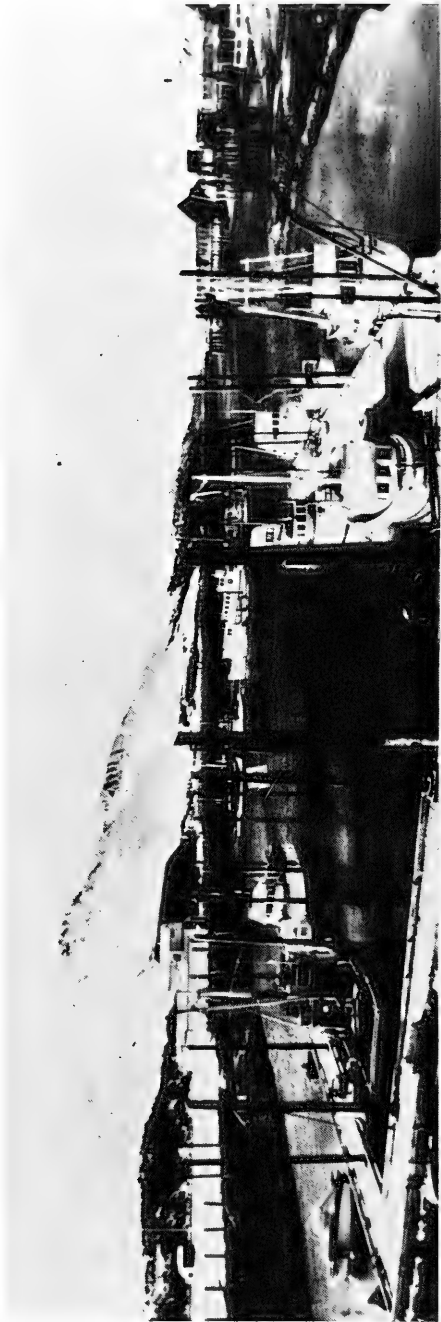
Figure 180 Composite View of the Small Boat Harbor and Docks at Valdez just a day or two before the Earthquake. The ferry slip shows at right center field with the Cannery behind it. Near the entrance on the right are the North Arm Docks and Warehouses where the CHENA was moored. In left center field is the Cannery on the South Arm. The GYPSY may be seen in the background just to the left of the closest pile in center foreground. (Photograph by Loren St. Amand, Copper River, Alaska)

The slides caused both docks with their warehouses and canneries to disappear; also, the breakwater protecting the small-boat harbor disappeared. Figure 180 is a panoramic view of the small-boat harbor just a day or two before the calamity. Figure 181 in contrast is an aerial view of the waterfront the day after the earthquake.

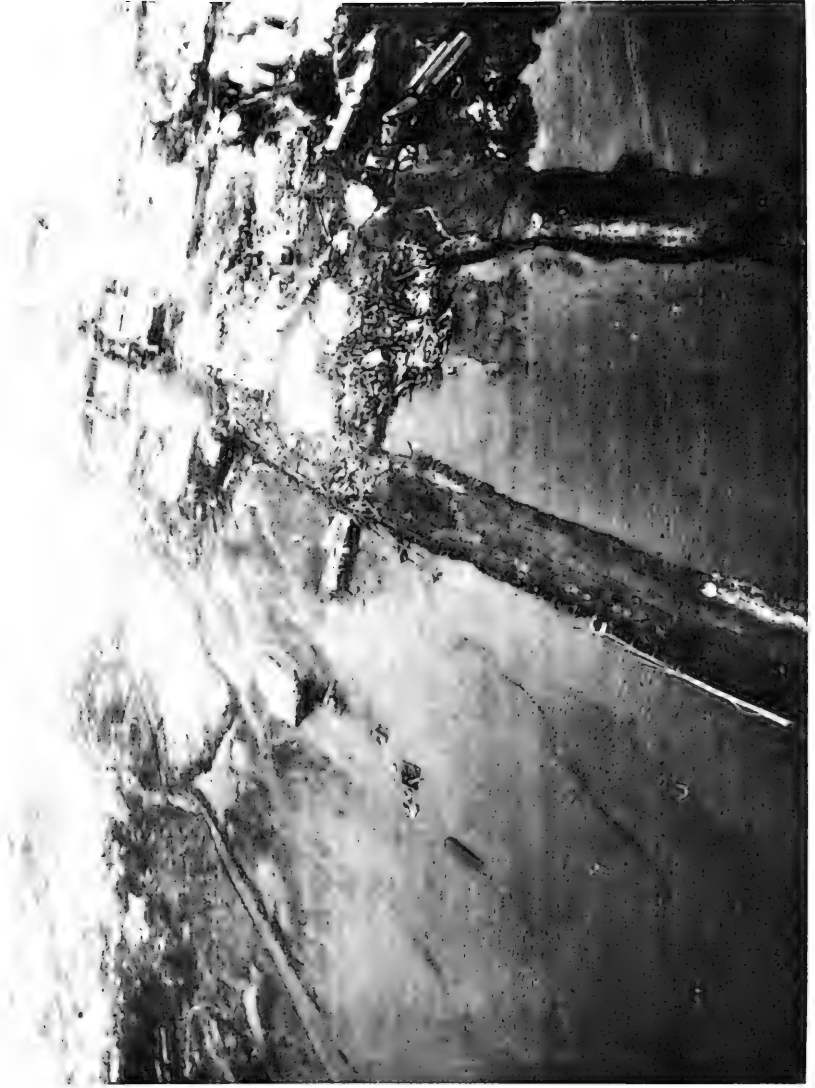
Figure 181 Aerial view of the Valdez waterfront after the Earthquake and Tsunami.

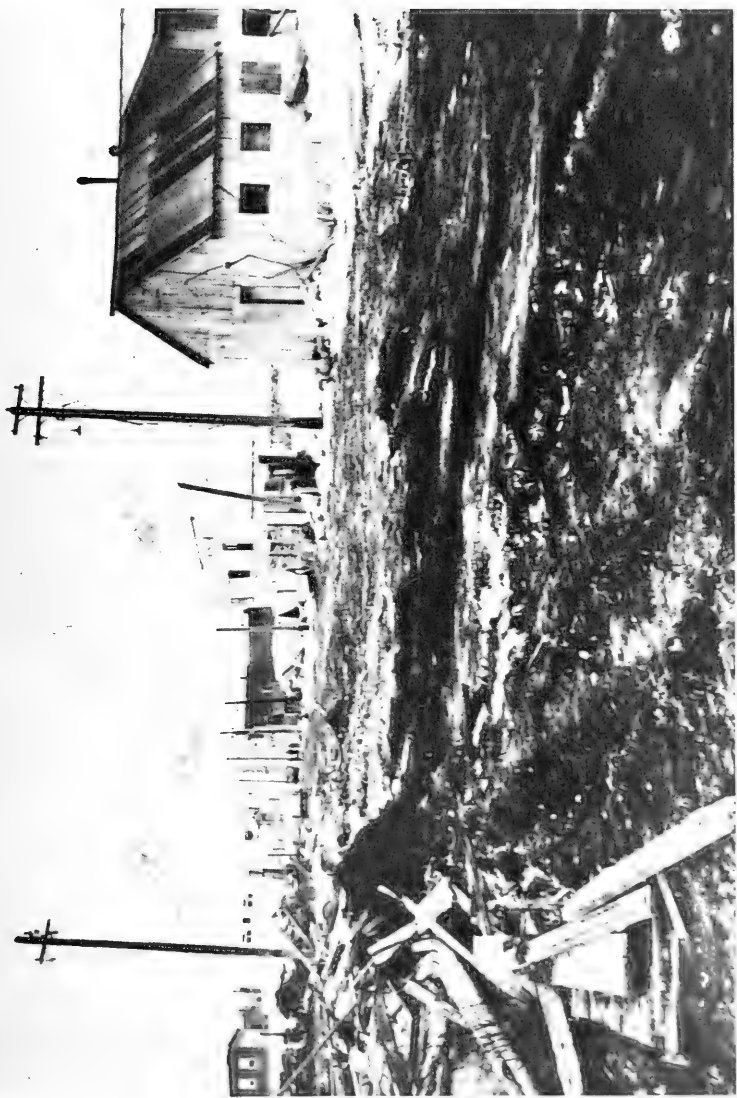
Figure 182 Looking east along Alaska Avenue. (Photograph by U. S. Army)

This wave also destroyed three of four buildings at the head of the small-boat harbor and another building along Alaska Avenue (see Figures 166 and 182). The buildings, like the majority of buildings in Valdez, were of light wooden frame construction. Particulars of a few buildings damaged or destroyed are given in Table IX. Their location is identified by number in Figure 179.

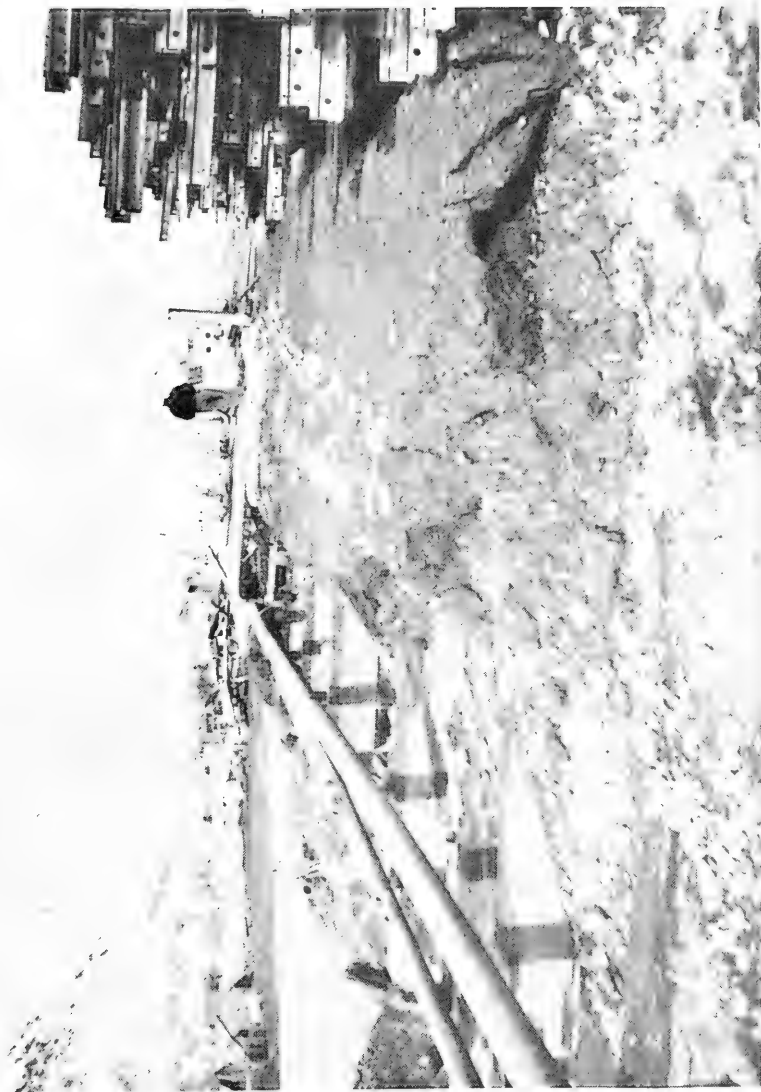
Figure 183 The eroded approach ramp to the North Dock. (Photograph by U. S. Army)

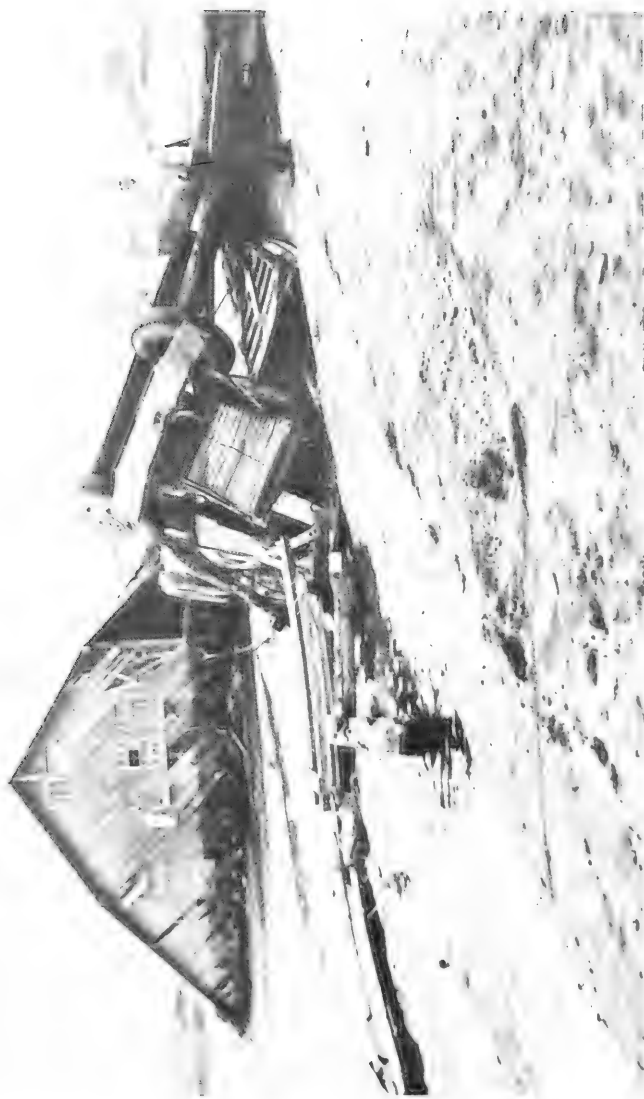
Figure 184 Cannery roof and truck on mud flats east of Harbor.  
(Photograph by Loren St. Amand, Copper River, Alaska)

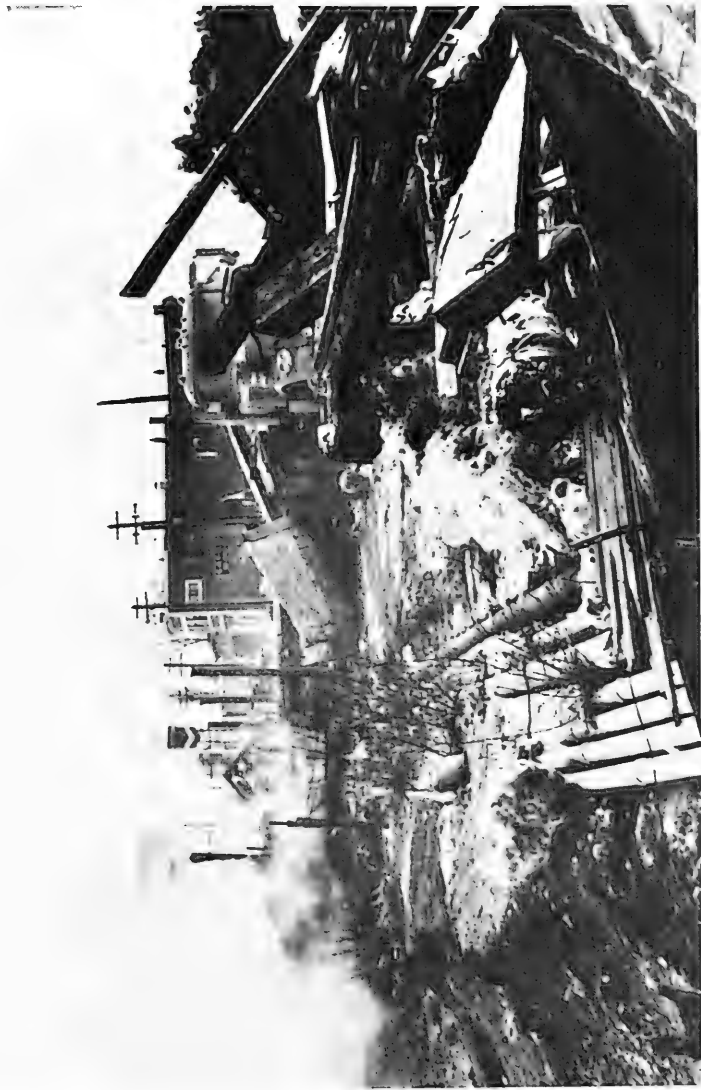
Figure 186 Looking east on Alaska Avenue before cleanup. (Photograph by Loren St. Amand, Alaska State Archives)

The high waves that came in about 11:45 and 1:35 during the night had apparently no smashing effects. However, they refloated boats and debris; and also some of the wooden structures were floated free, but were apparently not moved very much. These two waves were responsible for most of the wetting damage to buildings, homes, merchandise and supplies in the commercial establishments along McKinley Street and west of it. The water was heavily laden with silt and large volumes of silt were deposited in and around buildings. The backwash of the last wave had a strong current, and debris and beached boats were washed out into the bay. Some of the general melee on the waterfront is illustrated in Figures 186 and 187.

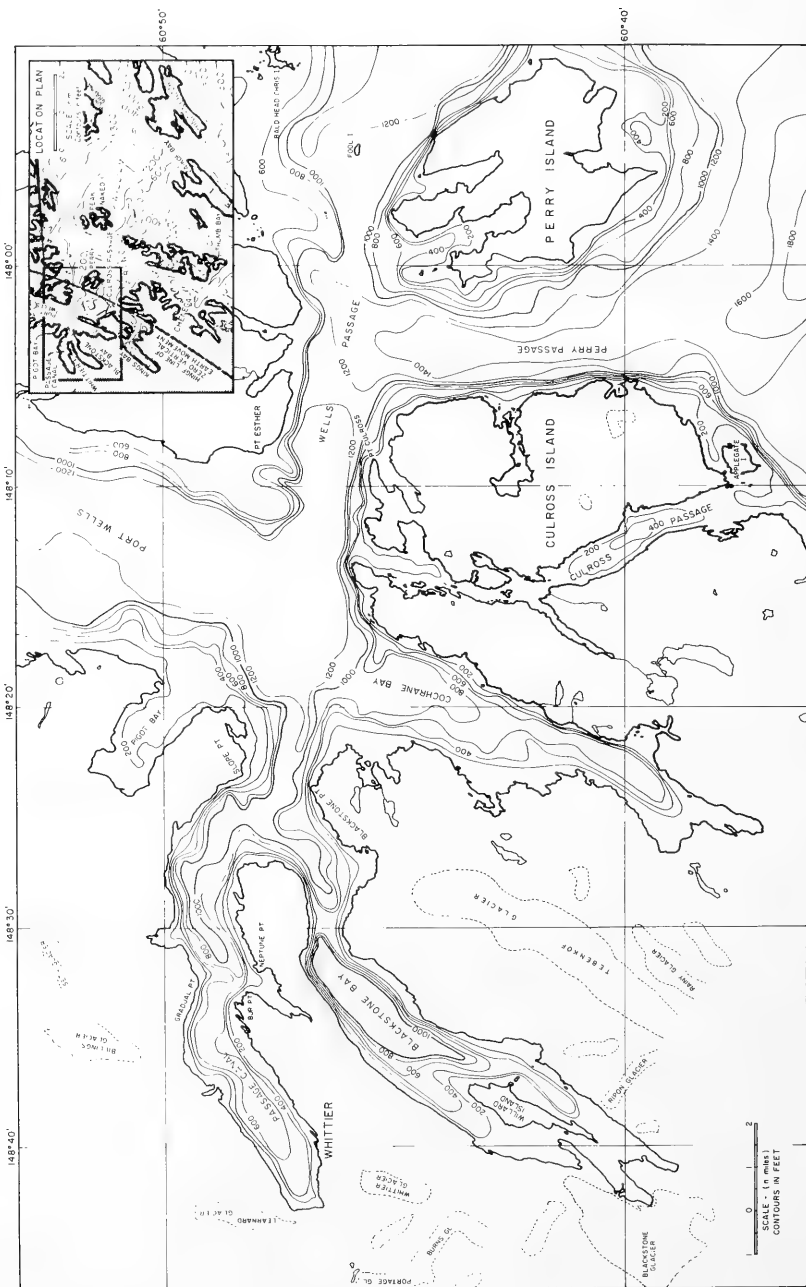
Figure 188 Bathymetry of Port Wells and tributary fjords including Passage Canal and Whittier, Prince William Sound.

Whittier was built in 1942-43 to provide a second all-weather terminal (besides Seward) for the Alaska Railroad. Figure 188 shows its location near the head of Passage Canal in Prince William Sound, one of a series of fingerlike fjords that connect with Port Wells and Wells Passage. The town is owned and operated by the Alaska Railroad of the U. S. Department of the Interior. However, some of the land has been leased to private enterprises. As a result of the earthquake, 13 of the 70 people living in Whittier died.

Figure 188 shows that Port Wells and its tributary fjords are a relatively deep and intricate system of connecting basins whose oscillating characteristics are apt to be complex. No attempt has been made to determine this oscillating regime. It may be noted from Figure 188 (inset) that Whittier lies on the northwest side of the hinge line of zero vertical earth movement running through Prince William Sound.

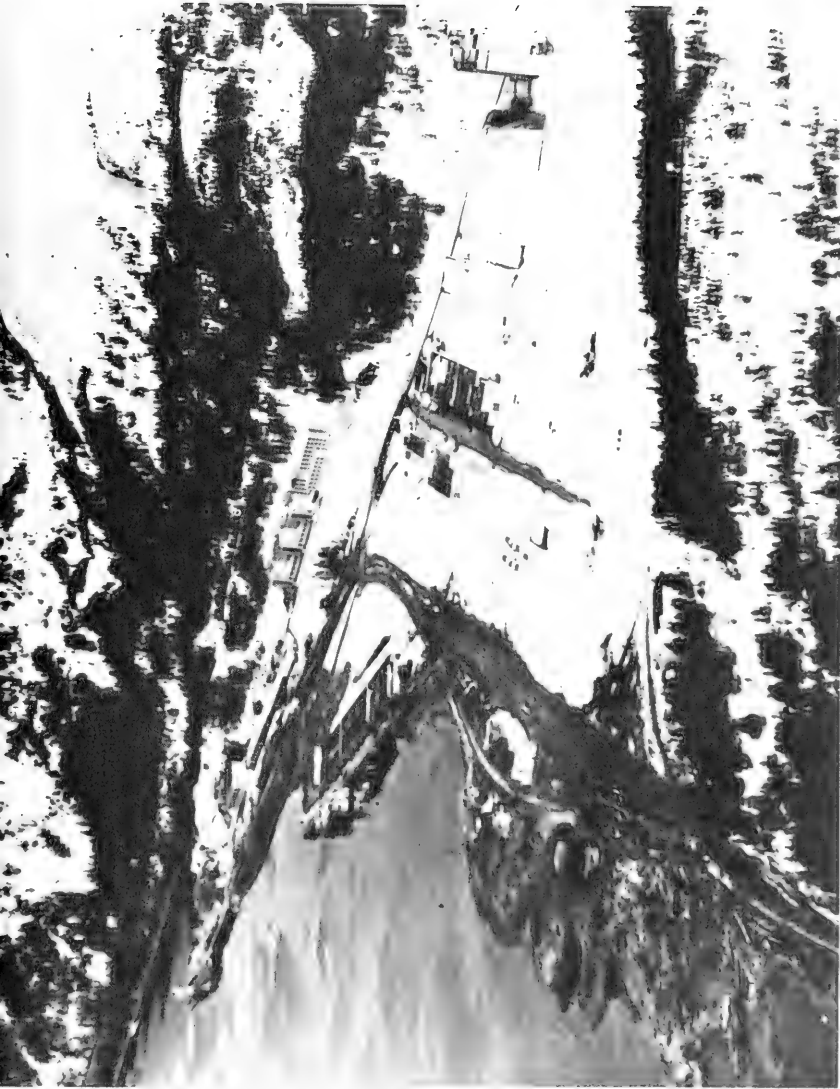
Figure 194 Aerial view of Whittier after the Earthquake showing the devastation of the waterfront. (Photograph by U. S. Army)

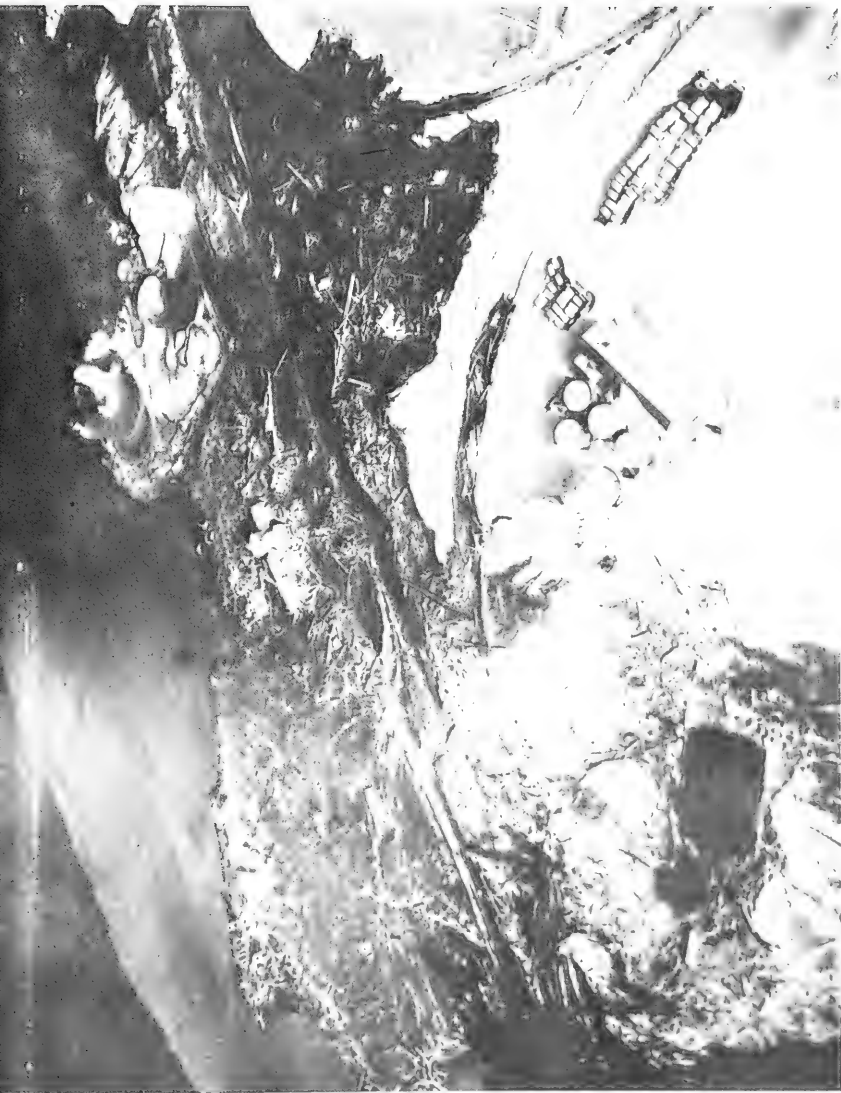
Figure 196 Aerial view of the west end of Whittier looking north. Union Oil Company Tank Farm is ablaze at upper right. Columbian Lumber Company plant, camp and dock at upper left is a shambles. Runup limit of the waves is etched in the snow. (Photograph by U. S. Army)

The Columbian Lumber Company plant and camp were completely wiped out by the waves. Almost nothing remains of the facilities which occupied the west end of the waterfront at Whittier (see Figure 196). Of the 13 people who died, 12 were in a camp building of the lumber company.

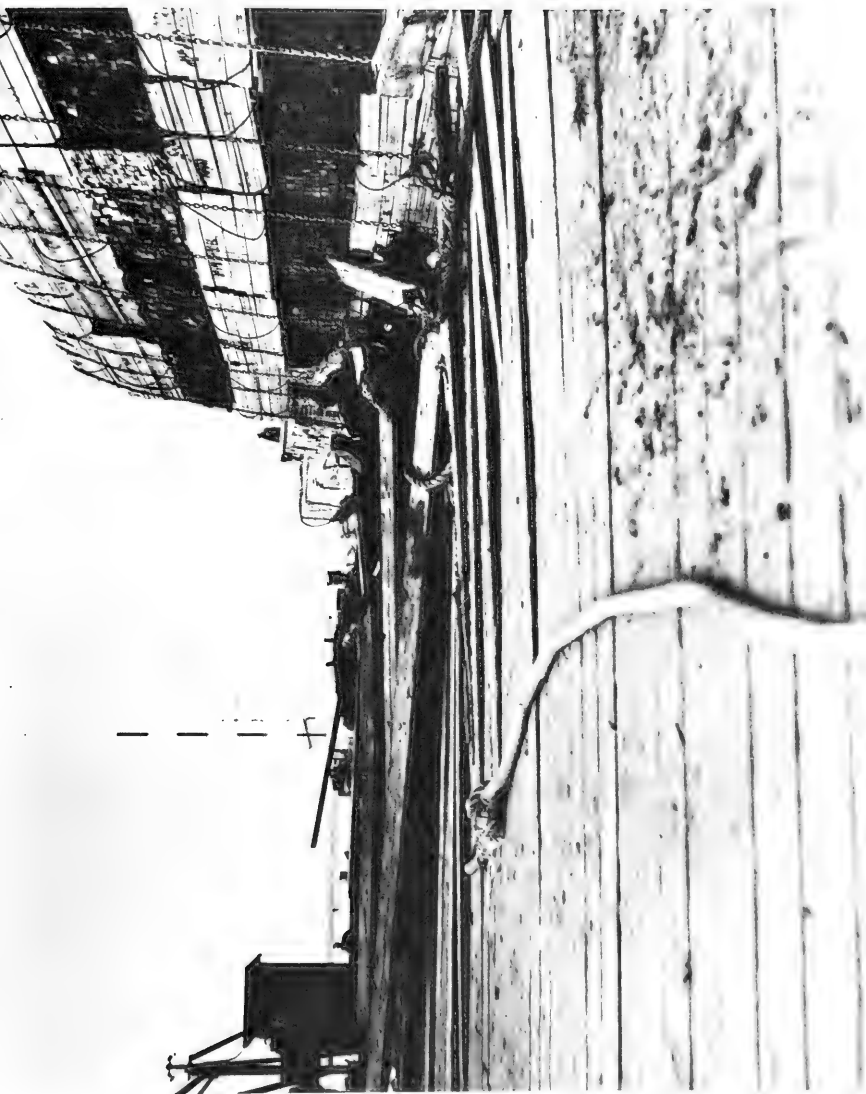
Figure 21) Lumber Barge alongside damaged Citizens Dock at Crescent City, California  
(Photograph by U. S. Coast Guard)

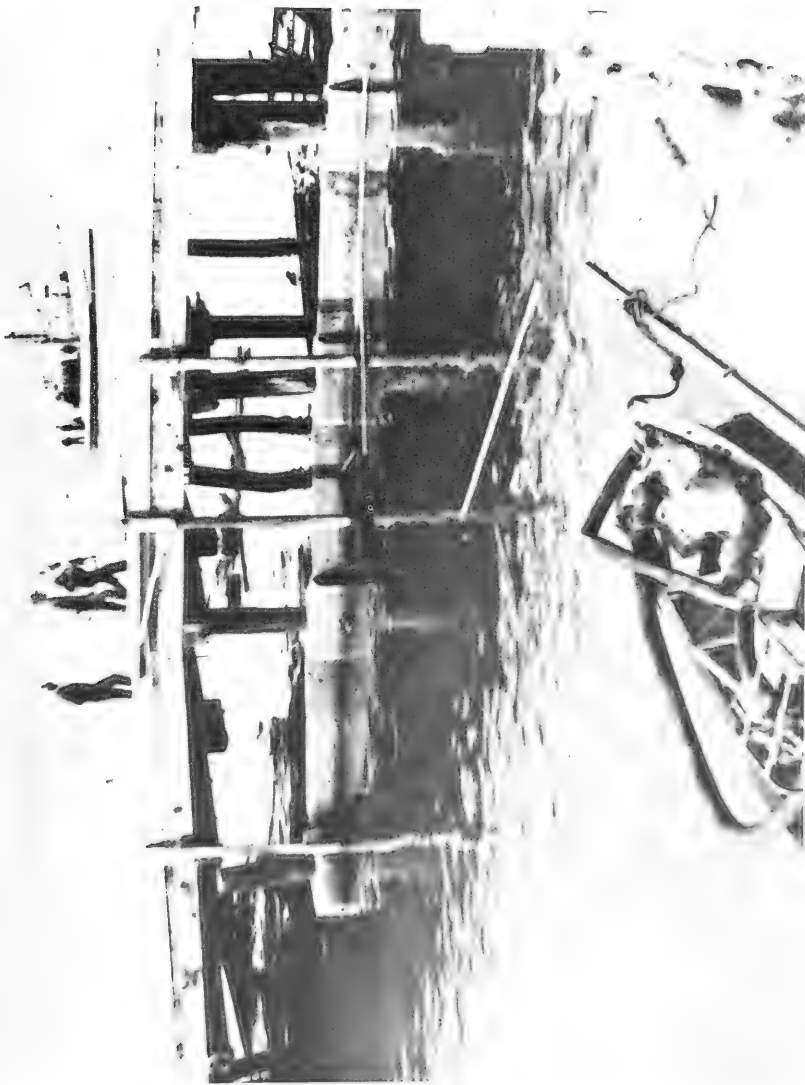
Figure 220 Approach to the Citizens Dock damaged by the Tsunami. Part of the concrete wave barrier surrounding supporting piles has been displaced and torn away. (Photograph by Orville Magoon, San Francisco)

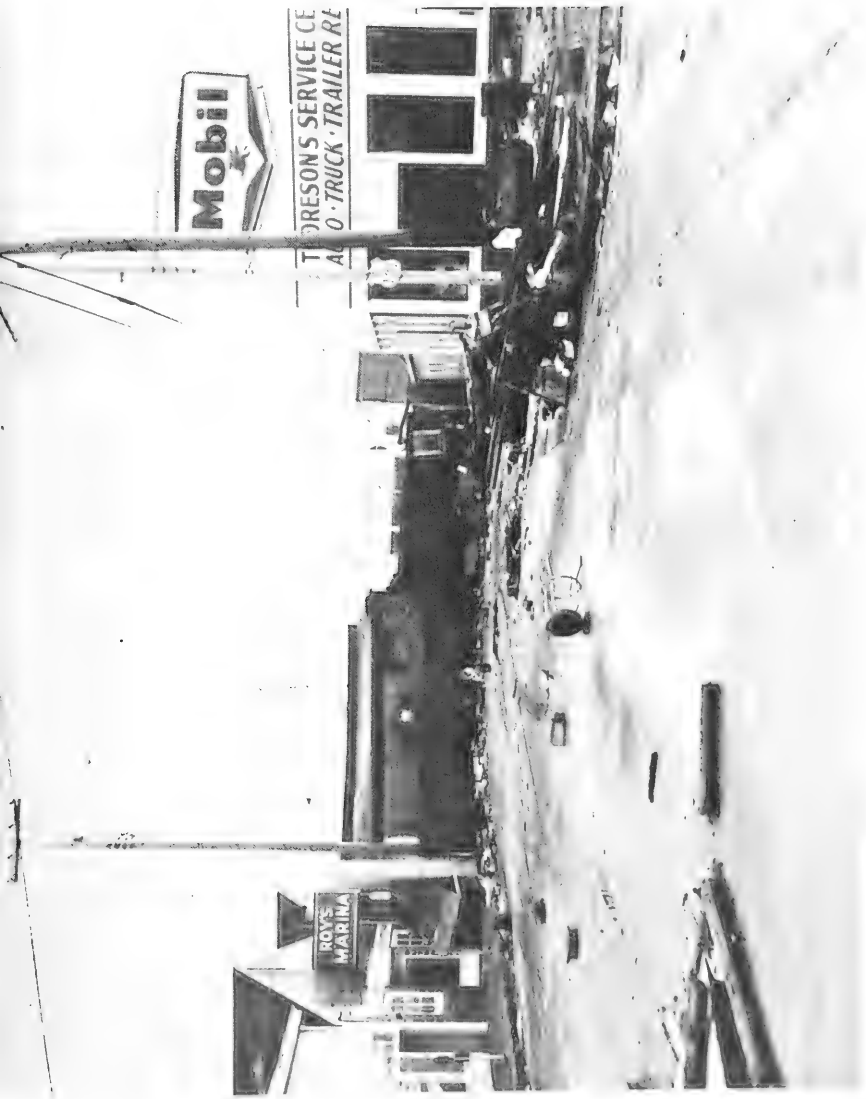
Figure 221 Typical scene of destruction in the downtown area of Crescent City. (Photograph by Harris Studio, Crescent City, California)
